SERVICE BULLETIN NO. SB-112-75

DATE DEC 7, 2017

INSPECTION OF MAIN LANDING UPPER SIDE BRACE

MODELS AFFECTED: Model 112/112B, S/N 3 thru 544 and 13000; Model 112TC/112TCA, S/N 13001 thru 13309

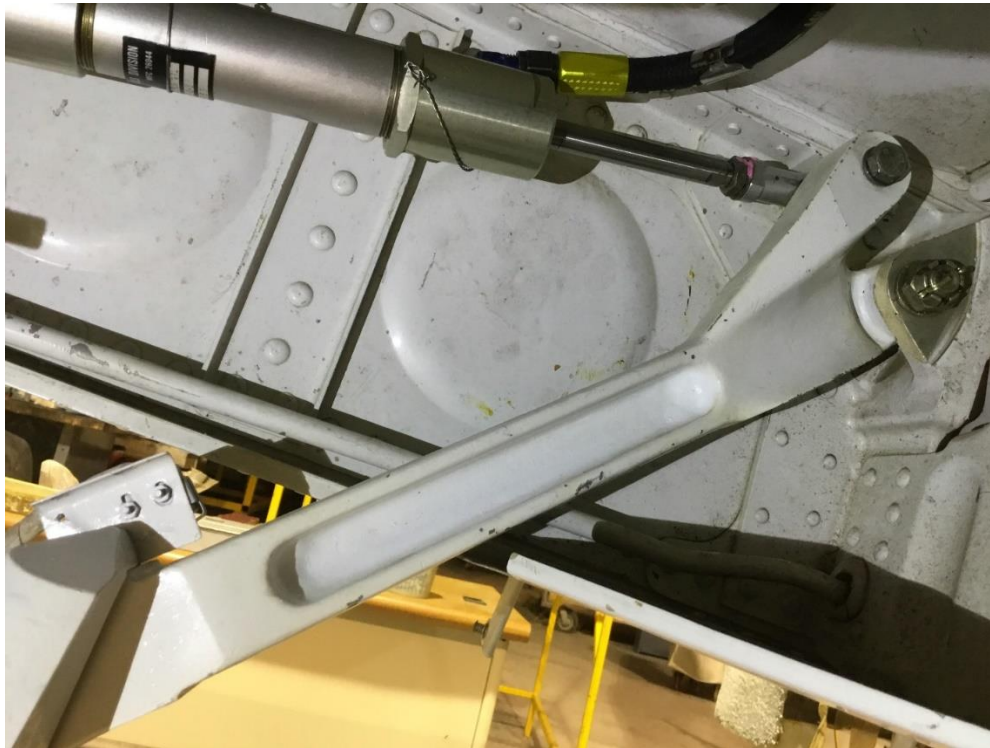
Photo 1

1. With the P/N 45303-1/-2 upper side brace in place, inspect all surfaces along the length of the link, with close attention to the upper and forward/aft surfaces in the transition area of the retraction cylinder lug.

Reference photos, 1, 2 and 3 for general location (R/H side shown). If close visual inspection shows no

2. If close visual inspection indicates possible cracking of the link, proceed to further inspection by performing dye check of the suspect area, or by additional methods as may be required.

4. If the further evaluation of the P/N 45303-1/-2 side brace assembly considers it to be not repairable, replace it with a serviceable part.
